# Manhole Inspection Summary

## Manhole # S21WW1024MH

Insp Date: **8/12/08 11:13 AM**

**Location** Address: **CROSS KEYS**

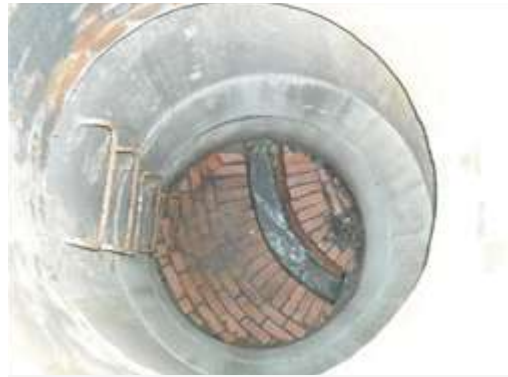
Top View

**Bench** ☒ Exists Material: **Brick** ☐ Parged ☒ **Debris** (not Condition related)

Bench debris.

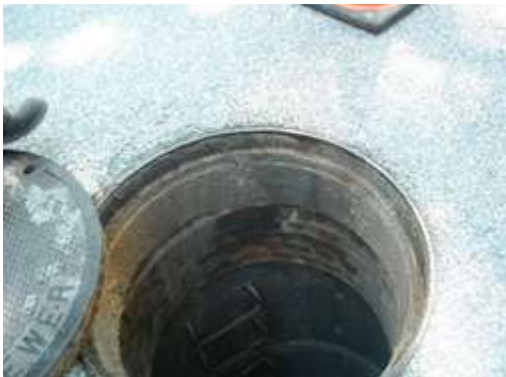
Defect

**Frame** Offset: **0** (in.) Condition: ☐ Sound ☐ Cracked ☒ **Leaks**

Infiltration: ☐ None ☒ **Joint** ☐ Cracks ☐ Mortar ☐ Roots ☐ Wall

Frame leaks. Adjustment and Corbel infiltration.

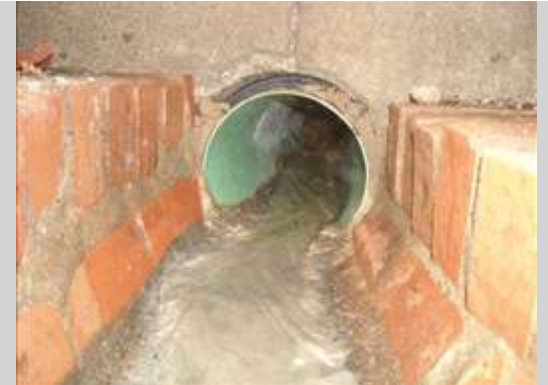
### 8 in. Circular Gravity Sewer Drop Out @ 12 O'Clock

Deposits: ☐ None ☐ Mud ☐ Sludge ☐ Debris ☒ **Grease**

Silt Depth: **0** (in.) Deposits Extent: **Light**

Infiltration: **Evidence** Pipe Seal Cond: **Unknown**

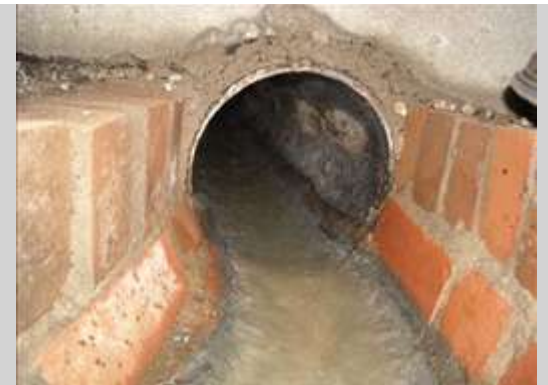
### 8 in. Circular Gravity Sewer Pipe In @ 4 O'Clock

Deposits: ☐ None ☐ Mud ☐ Sludge ☐ Debris ☒ **Grease**

Silt Depth: **0** (in.) Deposits Extent: **Light**

Infiltration: **Evidence** Pipe Seal Cond: **Unknown**
